Monitoring Data Record

Project Title: R-2417BA (Sites 14 and 22) COE Action ID: 2002-2-0899
 Stream Name: UT Bull Run DWQ Numbers: 001432
 City, County and other Location Information: Lee County, US 421-NC 87 Sanford Bypass from East of US 1-15-501 to East of SR 1521
 Date Construction Completed: Site 14 (May 2003) & Site 22 (April 2004)
 Monitoring Quarter: (4) of 8
 Ecoregion: _____ 8 digit HUC unit: 03030004
 USGS Quad Name and Coordinates: _____

4th Quarter – February 2007

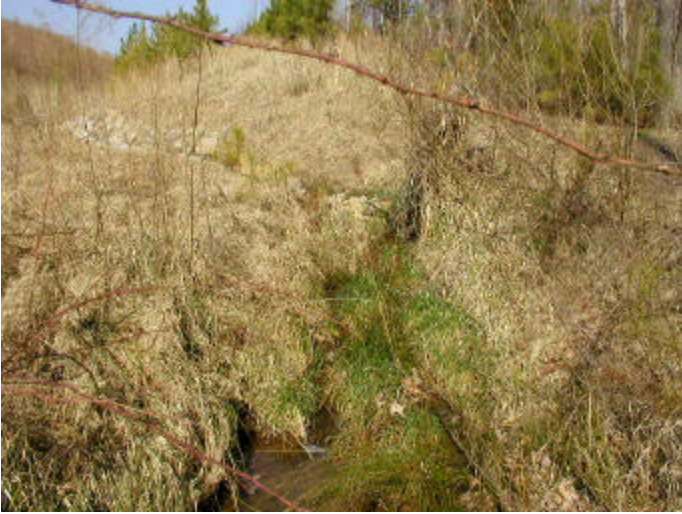
Photo 1

Site 14 stream relocation at Sta. 133+90 LT. has a slight headcut where the relocated stream ties back to the existing stream. The site is stabilized and will continue to be monitored.

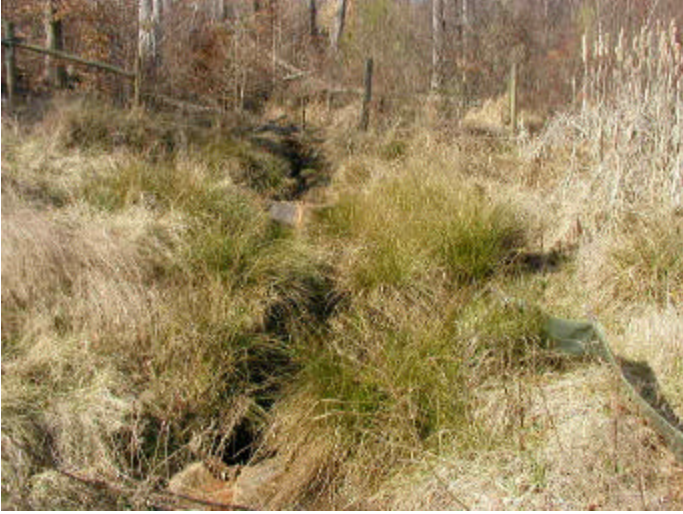
Photo 1

Site 22 stream relocation at Sta. 146+00 RT. has two cross vanes that were constructed without filter fabric per the plans. Water is currently flowing through the structures. There has been some localized erosion but the site has stabilized with vegetation. NCDOT will continue to monitor the site.
